Flood Control Project Maintenance
2009 Structure Summary Report
Overall Unit and Item Ratings

Lake County Watershed Protection District

Clover Creek Diversion Structure

Highland Canal Diversion Weir And Drainage Structure

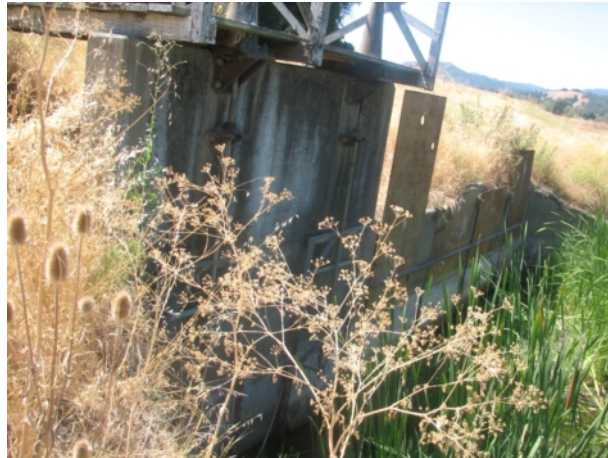
Levee Mile Report Line	1
Start Levee Mile	0.00
End Levee Mile	0.00
Location	
Category	Structures
Item	Photo Documentation
The view of the diversion structure gates at the intake.	
cathom_20090921_19.jpg

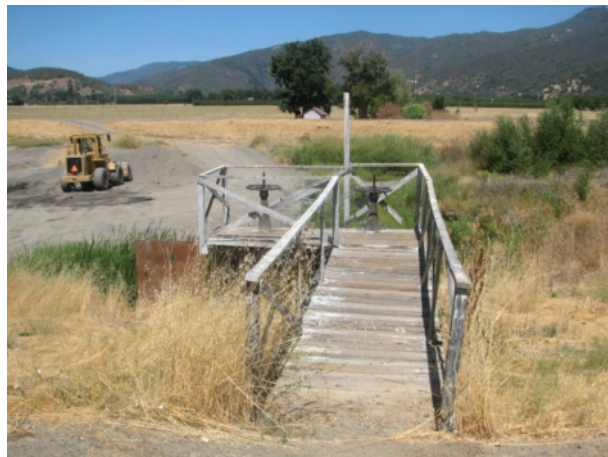
Levee Mile Report Line	1
Start Levee Mile	0.00
End Levee Mile	0.00
Location	
Category	Structures
Item	Photo Documentation
Walkway and control gate mechanisms.	
cathom_20090921_20.jpg

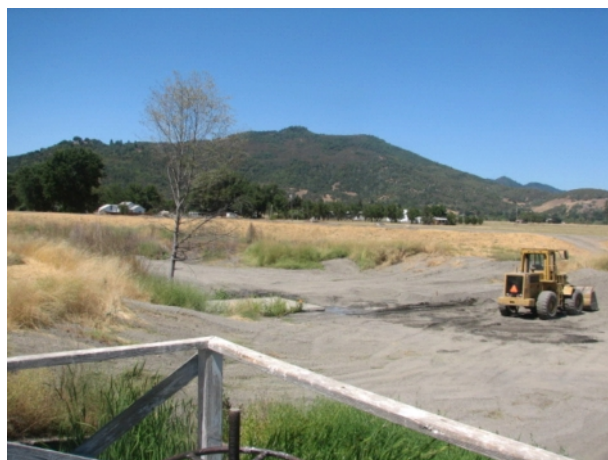
Levee Mile Report Line	1
Start Levee Mile	0.00
End Levee Mile	0.00
Location	
Category	Structures
Item	Photo Documentation
view of the concrete weir downstream of the diversion structure in the bypass channel, sediment being removed.	
cathom_20090921_21.jpg

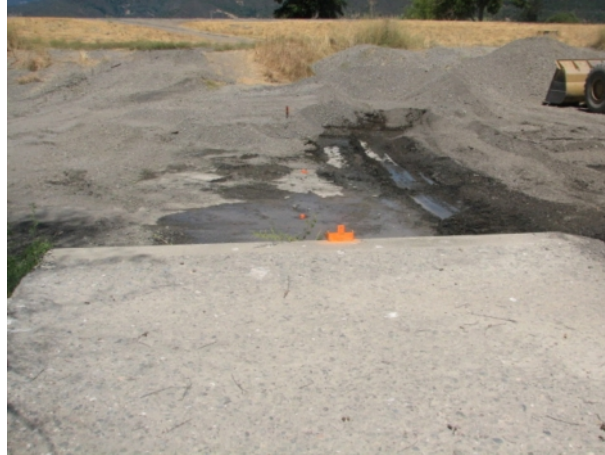
Levee Mile Report Line	1
Start Levee Mile	0.00
End Levee Mile	0.00
Location	
Category	Structures
Item	Photo Documentation
View of the concrete weir downstream of the diversion structure.	
cathom_20090921_22.jpg

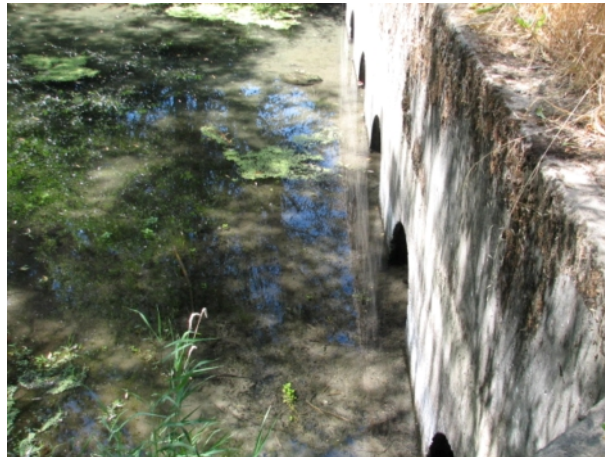
Levee Mile Report Line	1
Start Levee Mile	0.00
End Levee Mile	0.00
Location	
Category	Structures
Item	Photo Documentation
view of the structure outlet sediment buildup has reduced flow.	
cathom_20090921_23.jpg

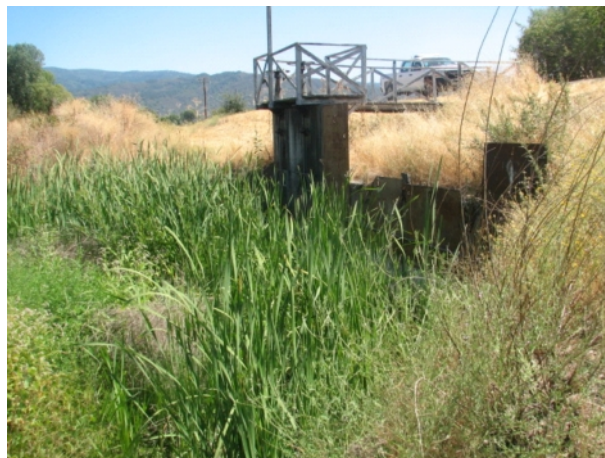
Levee Mile Report Line	2
Start Levee Mile	0.00
End Levee Mile	0.00
Location	
Category	Structures
Item	Vegetation & Obstructions
Vegetation in the channel near the intake structure.	
cathom_20090921_24.jpg

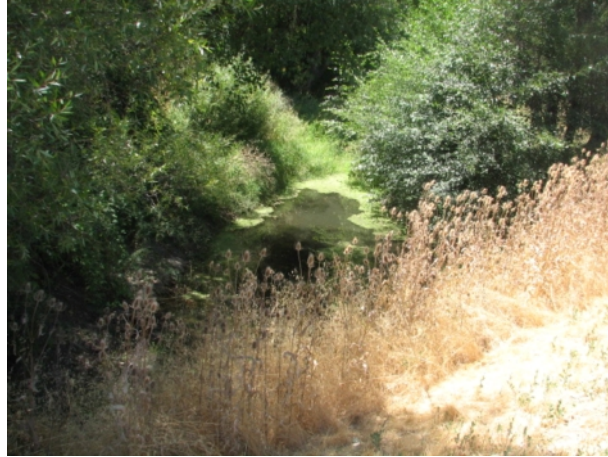
Levee Mile Report Line	2
Start Levee Mile	0.00
End Levee Mile	0.00
Location	
Category	Structures
Item	Vegetation & Obstructions
Vegetation in the outlet channel.	
cathom_20090921_25.jpg

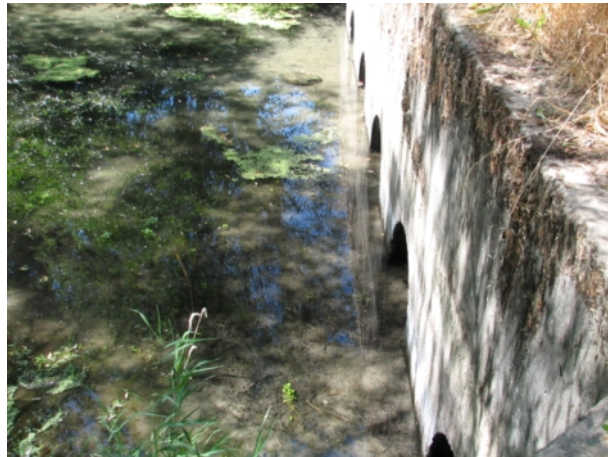
Levee Mile Report Line	7
Start Levee Mile	0.00
End Levee Mile	0.00
Location	
Category	Structures
Item	Culverts: Inlets / Outlets
View of the outlet pipes with sediment buildup.	
cathom_20090921_26.jpg

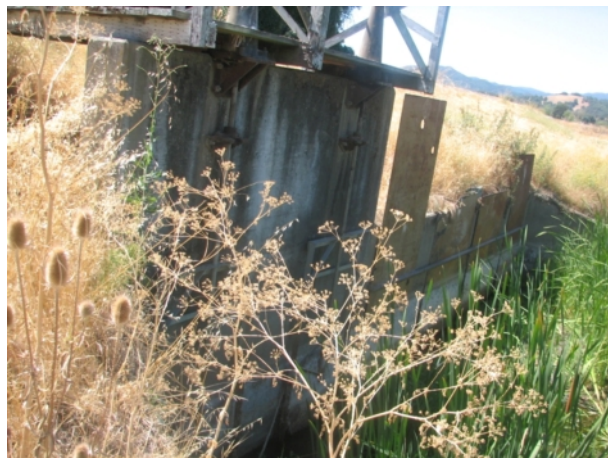
Levee Mile Report Line	12
Start Levee Mile	0.00
End Levee Mile	0.00
Location	
Category	Structures
Item	Sluice/Slide Gates
The inlet gates.	
cathom_20090921_27.jpg

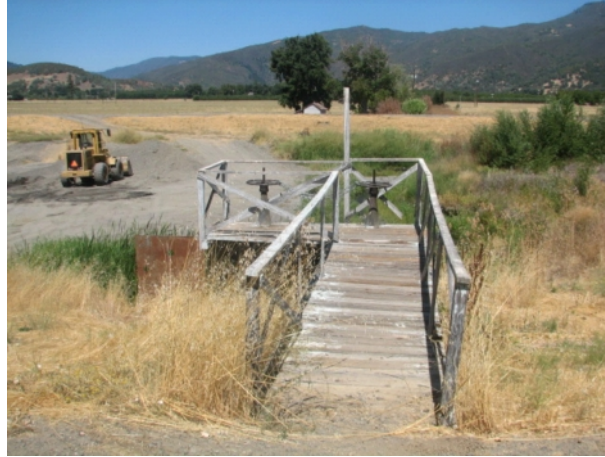
cathom_20090921_28.jpg

Levee Mile Report Line	12
Start Levee Mile	0.00
End Levee Mile	0.00
Location	
Category	Structures
Item	Sluice/Slide Gates

Walkway and control gates.

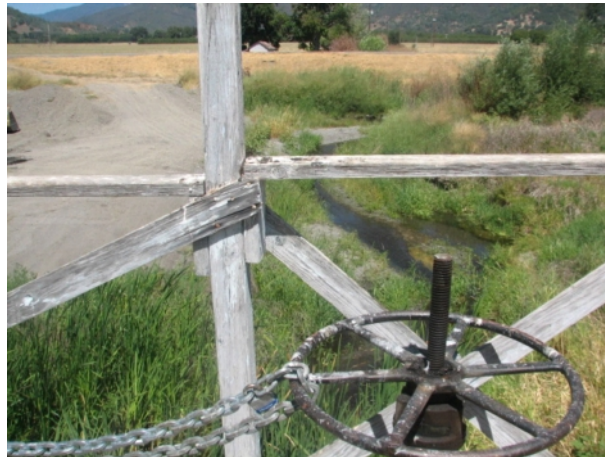
cathom_20090921_29.jpg

Levee Mile Report Line	12
Start Levee Mile	0.00
End Levee Mile	0.00
Location	
Category	Structures
Item	Sluice/Slide Gates

Control gate with chain locking in place.

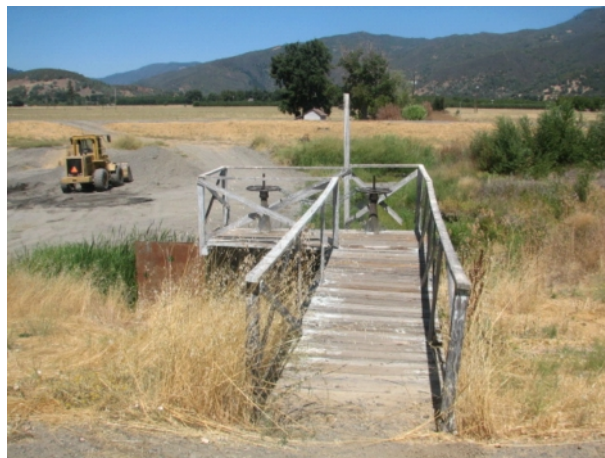
cathom_20090921_30.jpg

Levee Mile Report Line	14
Start Levee Mile	0.00
End Levee Mile	0.00
Location	
Category	Structures
Item	Manual Gate Operators

Walkway and control gates.

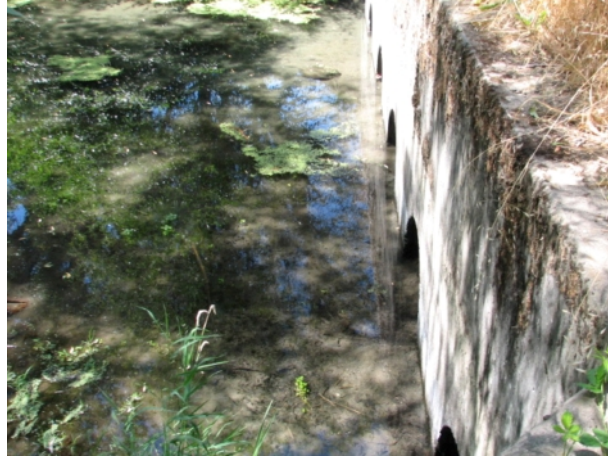
cathom_20090921_31.jpg

Levee Mile Report Line	15
Start Levee Mile	0.00
End Levee Mile	0.00
Location	
Category	Structures
Item	Concrete Surfaces

Downstream outlet.

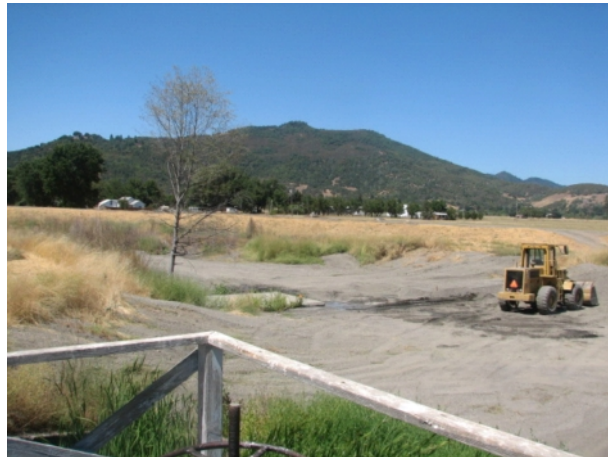
cathom_20090921_32.jpg

Levee Mile Report Line	15
Start Levee Mile	0.00
End Levee Mile	0.00
Location	
Category	Structures
Item	Concrete Surfaces

The concrete weir downstream from the diversion structure.

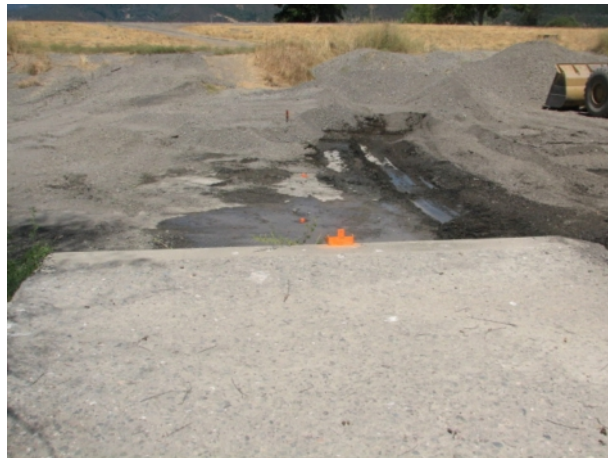
cathom_20090921_33.jpg

Levee Mile Report Line	15
Start Levee Mile	0.00
End Levee Mile	0.00
Location	
Category	Structures
Item	Concrete Surfaces

The weir in the bypass channel.

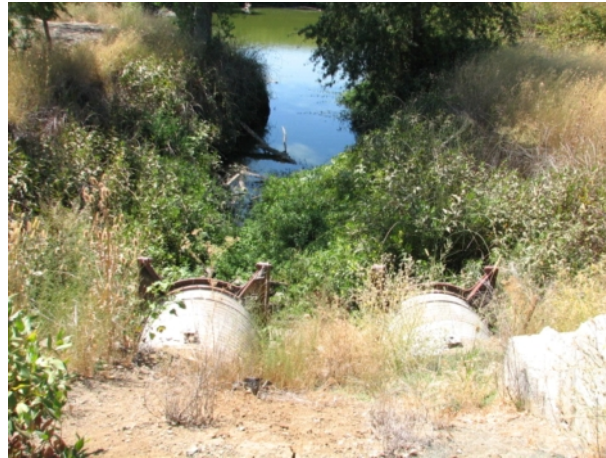
cathom_20090915_8.jpg

The view of the outlet pipes and channel.

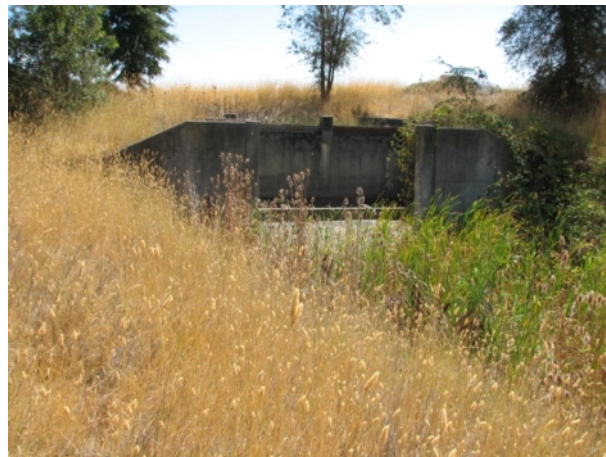
cathom_20090915_9.jpg

The concrete weir and the diversion pipe intake.

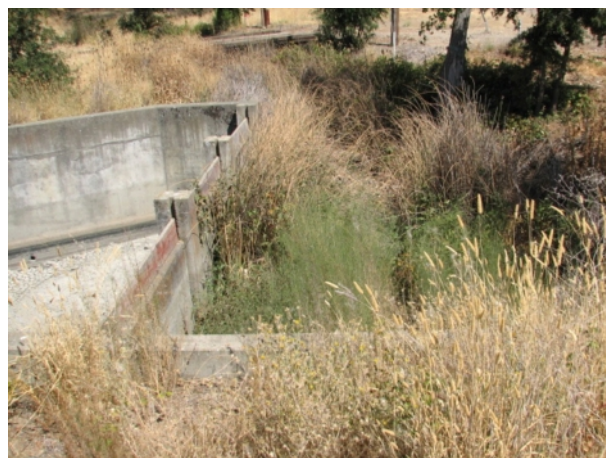
cathom_20090915_10.jpg

The down stream side of the weir and diversion pipe intake.

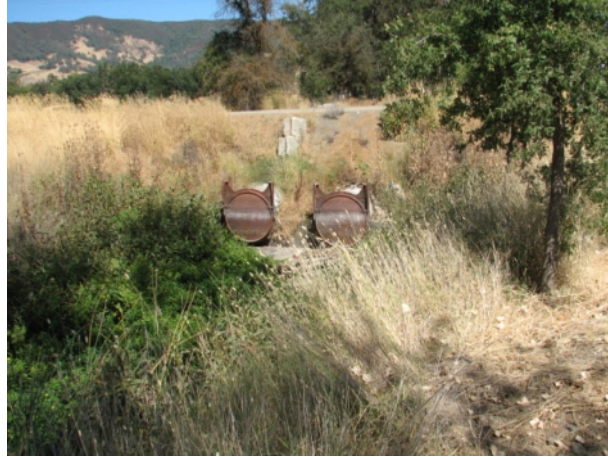
Levee Mile Report Line	1
Start Levee Mile	0.00
End Levee Mile	0.00
Location	
Category	Structures
Item	Photo Documentation
The flap gates on the outlet pipes.	
cathom_20090915_11.jpg

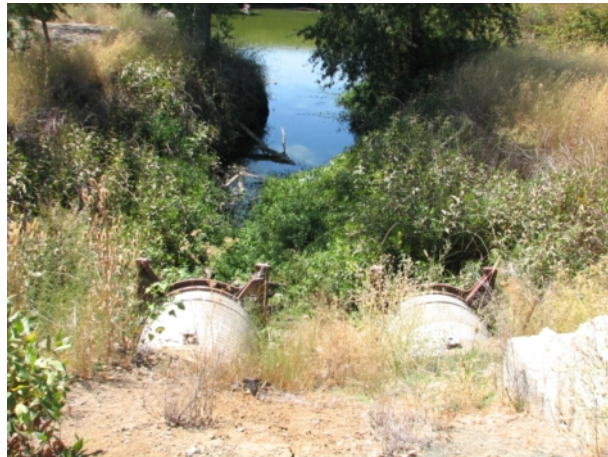
Levee Mile Report Line	2
Start Levee Mile	0.00
End Levee Mile	0.00
Location	
Category	Structures
Item	Vegetation & Obstructions
Moderate vegetation near outlet pipes.	
cathom_20090915_12.jpg

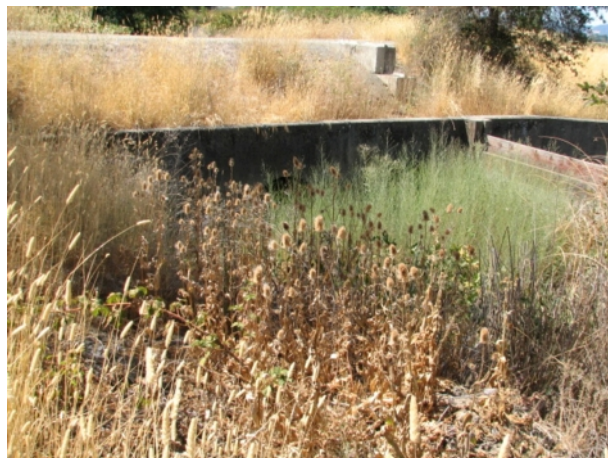
Levee Mile Report Line	2
Start Levee Mile	0.00
End Levee Mile	0.00
Location	
Category	Structures
Item	Vegetation & Obstructions
Vegetation near diversion pipe intake.	
cathom_20090915_13.jpg

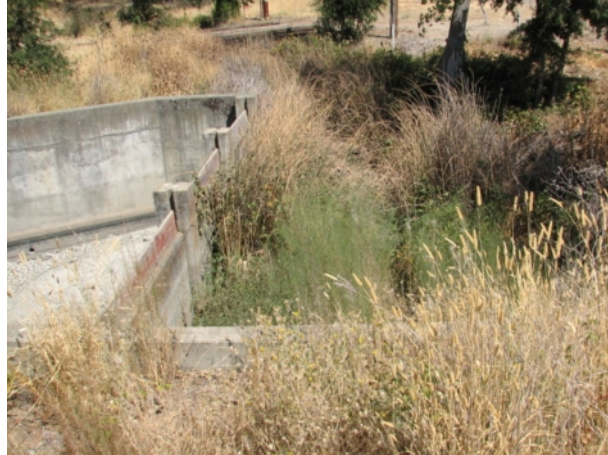
Levee Mile Report Line	7
Start Levee Mile	0.00
End Levee Mile	0.00
Location	
Category	Structures
Item	Culverts: Inlets / Outlets
Vegetation at the intake.	
cathom_20090921_14.jpg

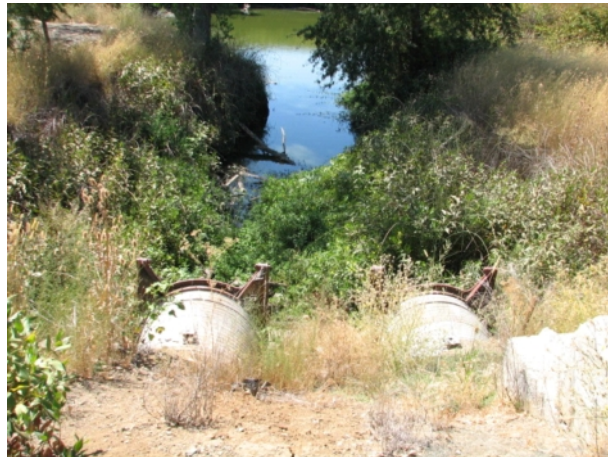
Levee Mile Report Line	7
Start Levee Mile	0.00
End Levee Mile	0.00
Location	
Category	Structures
Item	Culverts: Inlets / Outlets
Vegetation at the outlet.	
cathom_20090921_15.jpg

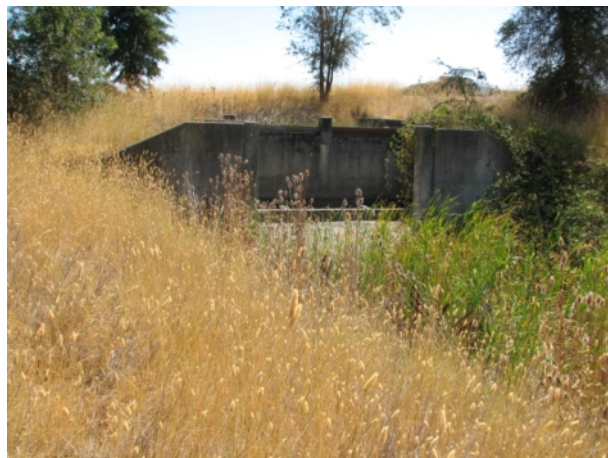
Levee Mile Report Line	7
Start Levee Mile	0.00
End Levee Mile	0.00
Location	
Category	Structures
Item	Culverts: Inlets / Outlets
The concrete weir and diversion pipe intake.	
cathom_20090921_16.jpg

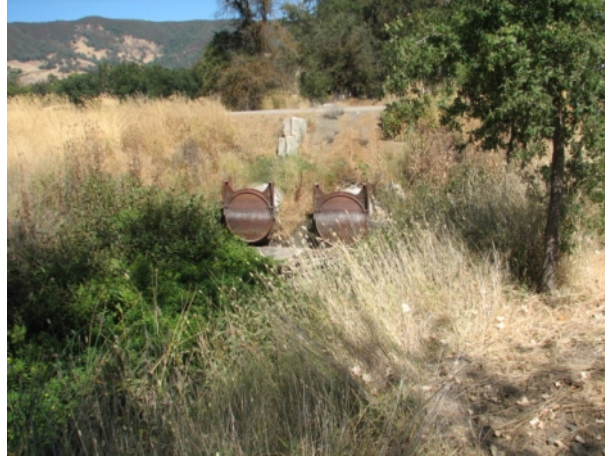
cathom_20090921_17.jpg

Levee Mile Report Line	11
Start Levee Mile	0.00
End Levee Mile	0.00
Location	
Category	Structures
Item	Flap Gates

Outlet flap gates.

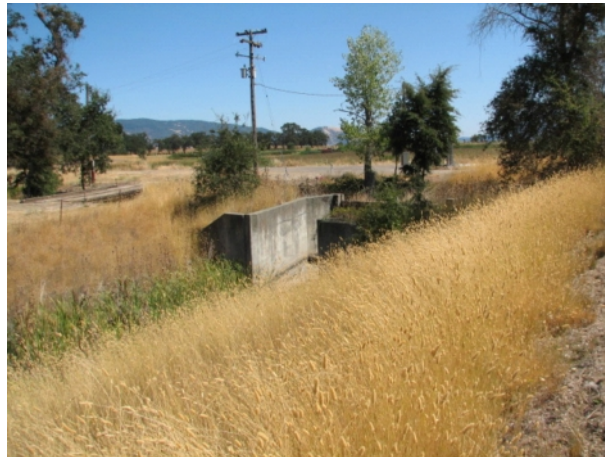
cathom_20090921_18.jpg

Levee Mile Report Line	15
Start Levee Mile	0.00
End Levee Mile	0.00
Location	
Category	Structures
Item	Concrete Surfaces

The weir.
